Manhole Inspection Summary

Manhole # **S11KK1016MH**

Location Address: **4703 HOMER AVE**

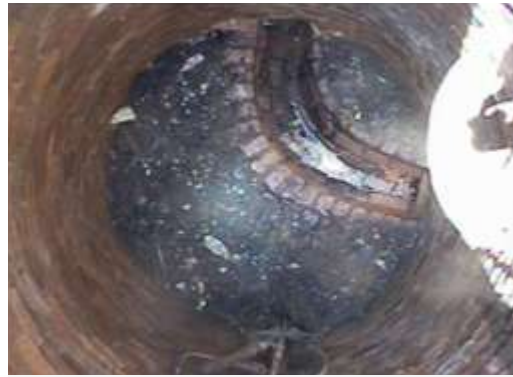
Top View

DEBRIS ON BENCH

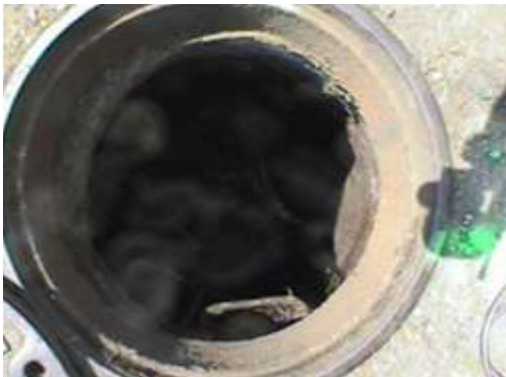
Defect 1

Frame Offset: **2** (in.) Condition: ☒ Sound ☐ Cracked ☐ Leaks

Steps Count: **5** Missing: **0** ☒ **Corroded**

FRAME OFFSET AND CORRODED
STEP

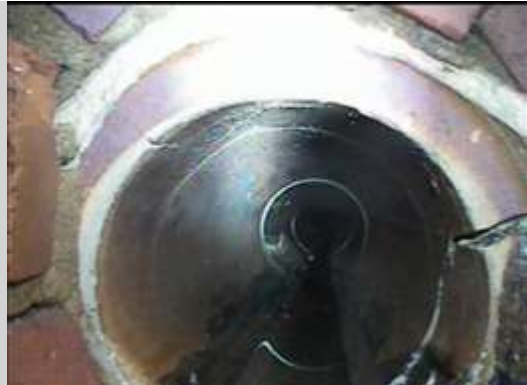
12 O'Clock Outflow

2 CRACKS IN SEAL @ 11 AND 3 O' CLOCK

Infiltration: **None** Pipe Seal Cond: **Cracked**
